# CAUTION Bulletin

**Title:** Mister Safety Hazards Identified

**Identifier:** 2006-RL-HNF-0008

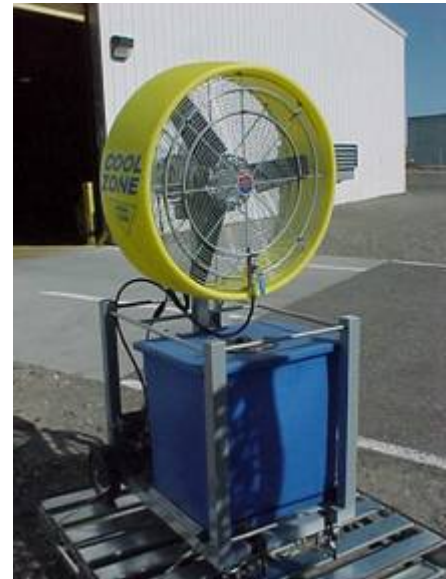
**Lessons Learned Summary:** CoolZone misters, shown at right, have been received with electrical and mechanical deficiencies that could pose safety hazards. They had an inadequately insulated pressure switch and discharge valves not rated for normal operating pressure.

**Discussion of Activities:** The Solid Waste Storage and Disposal (SWSD) Project at Hanford procured a number of water supplied mister fans from CoolZoneUSA, Las Vegas, NV, to cool personnel during hot weather. While units were undergoing mounting and initial operational testing, SWSD personnel discovered that the installed ball valves on the high pressure side were rated for only 600 psi but operating procedures call for adjusting pressure of the unit to 1,000 psi. The valves were replaced with 2,000 psi stainless steel ball valves.

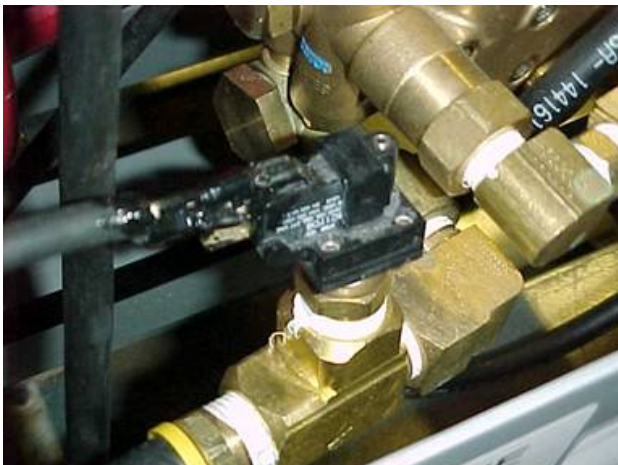
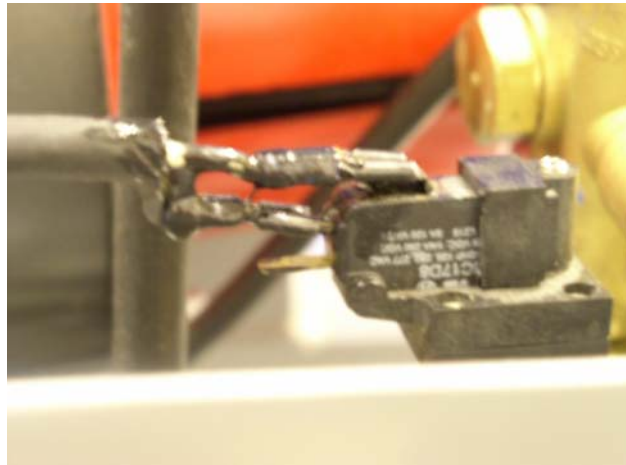
Waste Receiving and Processing Facility (WRAP) personnel discovered an exposed 120-volt termination on a pressure switch, shown below, that was insufficiently insulated on the units. Some type of paint or other coating was apparently used to cover a spade lug termination after it was installed. Electricians measured only 1 ohm of resistance across the material, an inadequate value to prevent an electrical shock. WRAP Electrical Engineering contacted the manufacturer who indicated that they (Cool Zone) had installed an incorrect pressure switch. They sent seven replacement pressure switches with enclosures to repair the defective switches on the units at Hanford.

Besides the obvious safety hazard from the pressure switches, lack of listing/labeling by an OSHA-recognized nationally recognized testing laboratory (NRTL) is an issue with this equipment. Although some parts are UL-Labeled, the appliance is not labeled as an assembly.

**Recommendations:** Any facilities with CoolZone fans should inspect their units for similar problems.

Three options are available to ensure that these misters are acceptable to the authority having jurisdiction (AHJ) after the pressure switches are replaced:

1. Schedule a field evaluation by an Underwriters Laboratory (UL) representative from a UL office (preferred option).
2. Conduct an on-Site evaluation using an appropriate electrical subject matter expert and the checklist, Non-NRTL ELECTRICAL EQUIPMENT AHJ APPROVAL REPORT.
3. Have the misters evaluated by a certified UL 508A shop.
